RESEARCH MEMORANDUM

ENGINE PERFORMANCE OF ALLOY 73J TURBINE BLADES

CAST TO PREDETERMINED GRAIN SIZES

By James R. Johnston, Charles A. Gyorgak and John W. Weeton

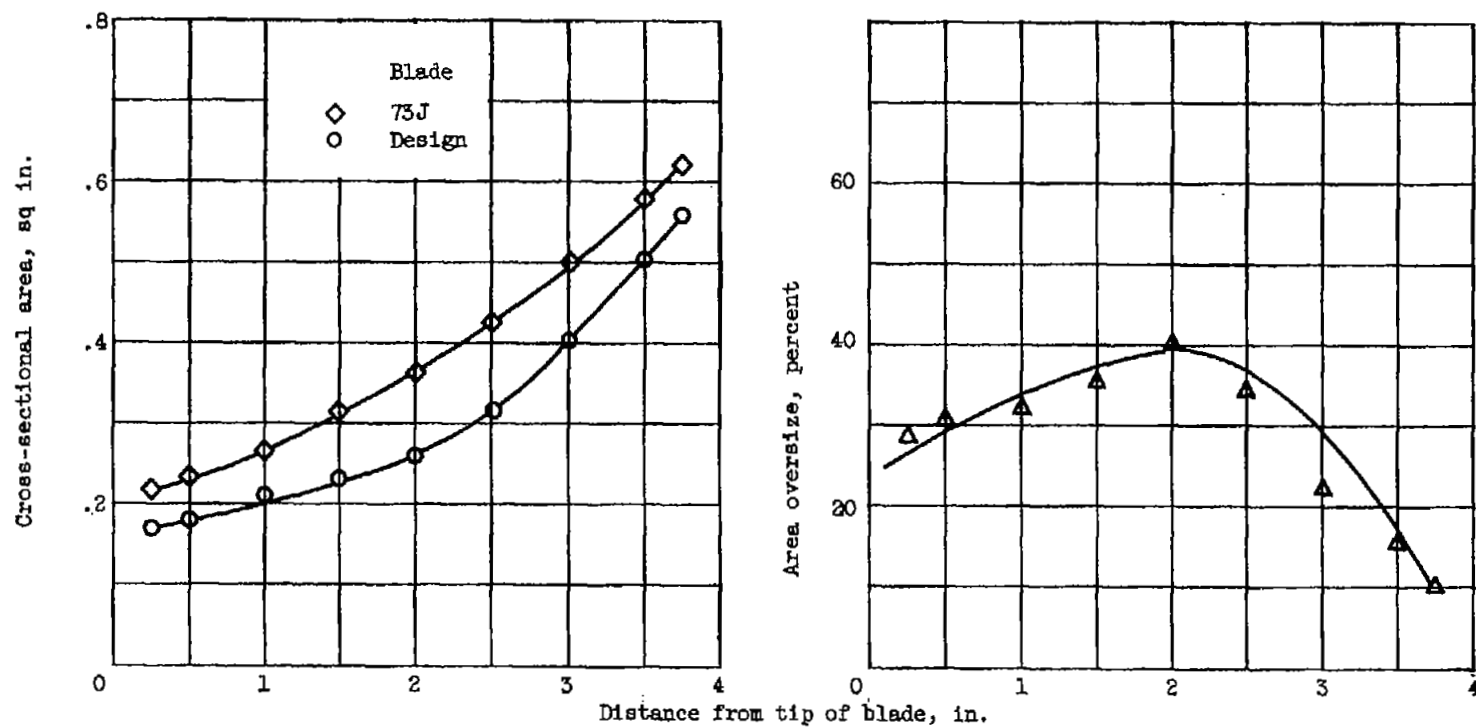
Figure 1. - Comparison of cross-sectional areas of 73J blade and designed blade.

Dimensional checking of the blades showed them to be oversize. The differences in cross-sectional area from the desired blade design are shown in figure 1. These differences in area at any cross section in the blade would tend to reduce the stress at that section, but the resultant greater volume of material beyond this cross section would tend to increase the load that the area must carry. The net result is that the centrifugal stress, calculated by the method described in reference 7, was slightly higher than that of a standard-shaped blade (fig. 2). The increase in cross-sectional area, however, may tend to stiffen the blade and reduce vibratory stresses.

The blades used in this investigation were ordered to standard J33-9 blade specifications. However, the blades were cast oversize. The area oversize varied from 10.5 percent in certain locations of the airfoils to as much as 40.5 percent (fig. 1). At the same time that these 73J blades were obtained from the manufacturer, Stellite 21 blades cast to different grain sizes were also obtained. These blades, also oversize, were run in an engine in a similar test and the results have been reported in reference 4. The Stellite 21 blades did not exhibit improved life over standard-size blades and therefore it appears that the oversize effect in the 73J blades could not have accounted for the excellent performance of this alloy as blade material. To further substantiate this conclusion, three 73J blades were electromachined to an undersized condition, three were electromachined to standard size, and these six along with six oversized 73J blades were run in another turbine wheel with other alloys. Unfortunately all these blades were damaged by impact from fractured blade fragments of other alloys and had to be removed from the engine before actual failure had occurred. It may be somewhat significant, however, that two of the electromachined blades had run 74 hours, one 91 hours, two 188 hours, and one 213 hours before removal without indications of incipient fatigue failure. These data indicate that very early fatigue failure may not occur in blades of standard dimensions.

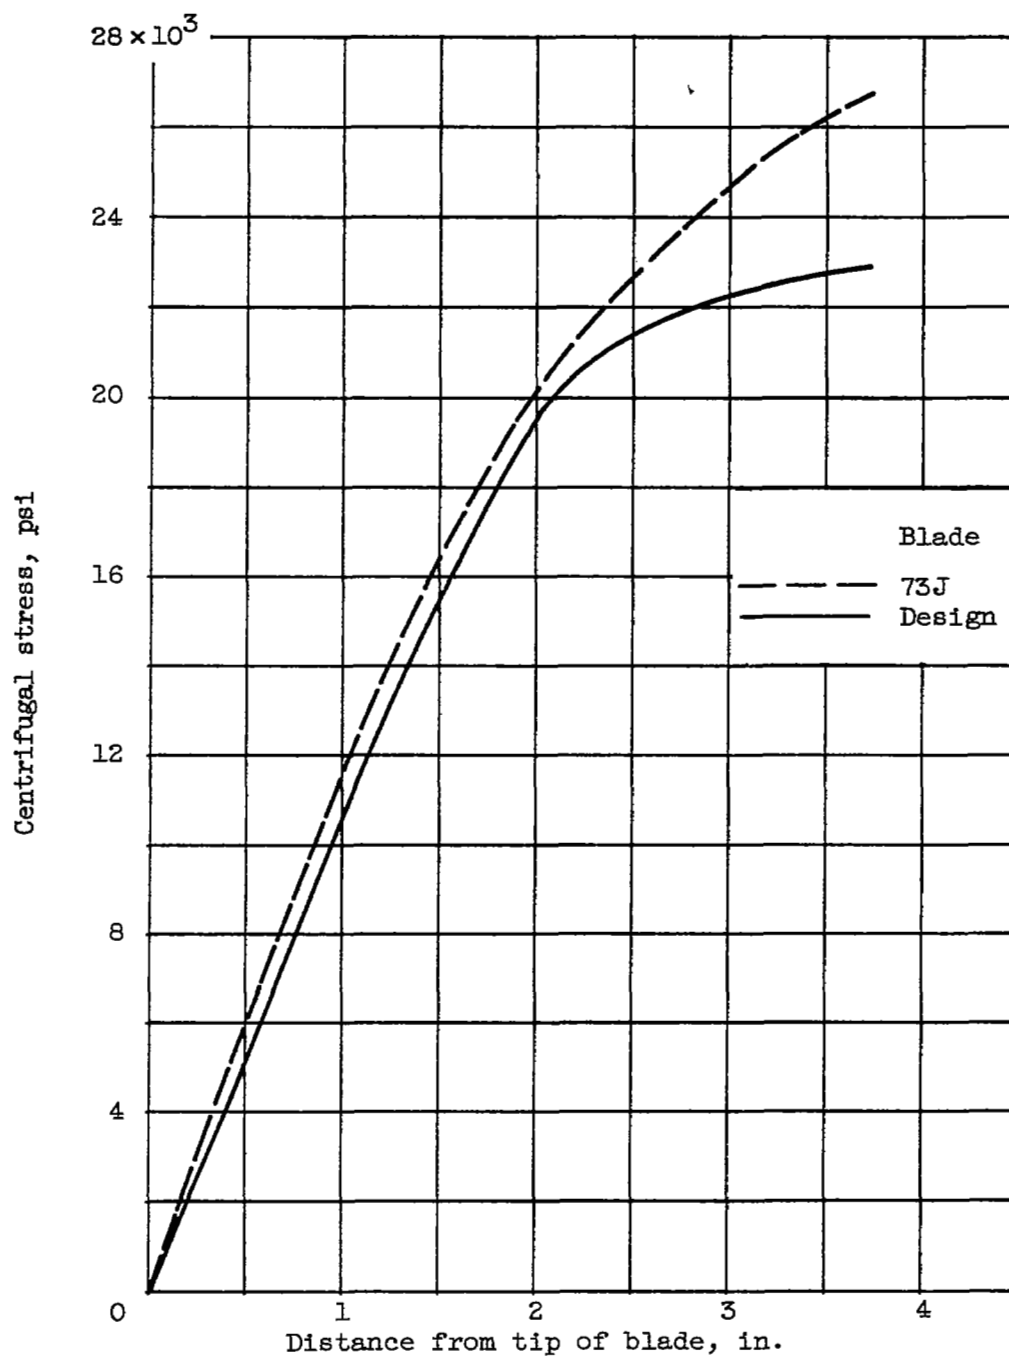
Figure 2. - Stress distribution of 73J blade compared with distribution calculated for designed blade.

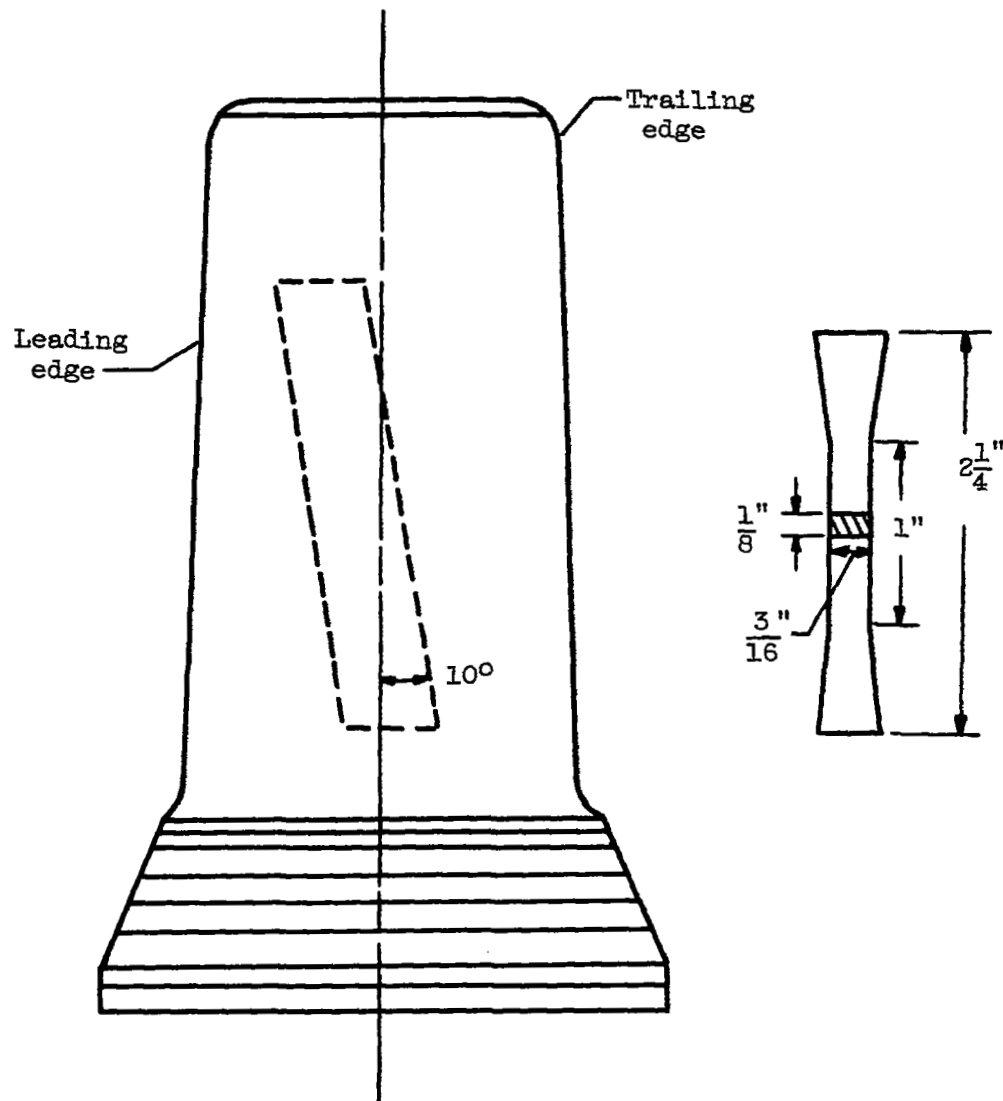
Figure 3. - Blade stress-rupture specimen and zone from which it was machined.

Stress-rupture specimens were taken from the airfoil section of the blade as shown in figure 3. The tests were made at the engine operating temperature and stress of 1500° F and 21,000 psi, respectively.

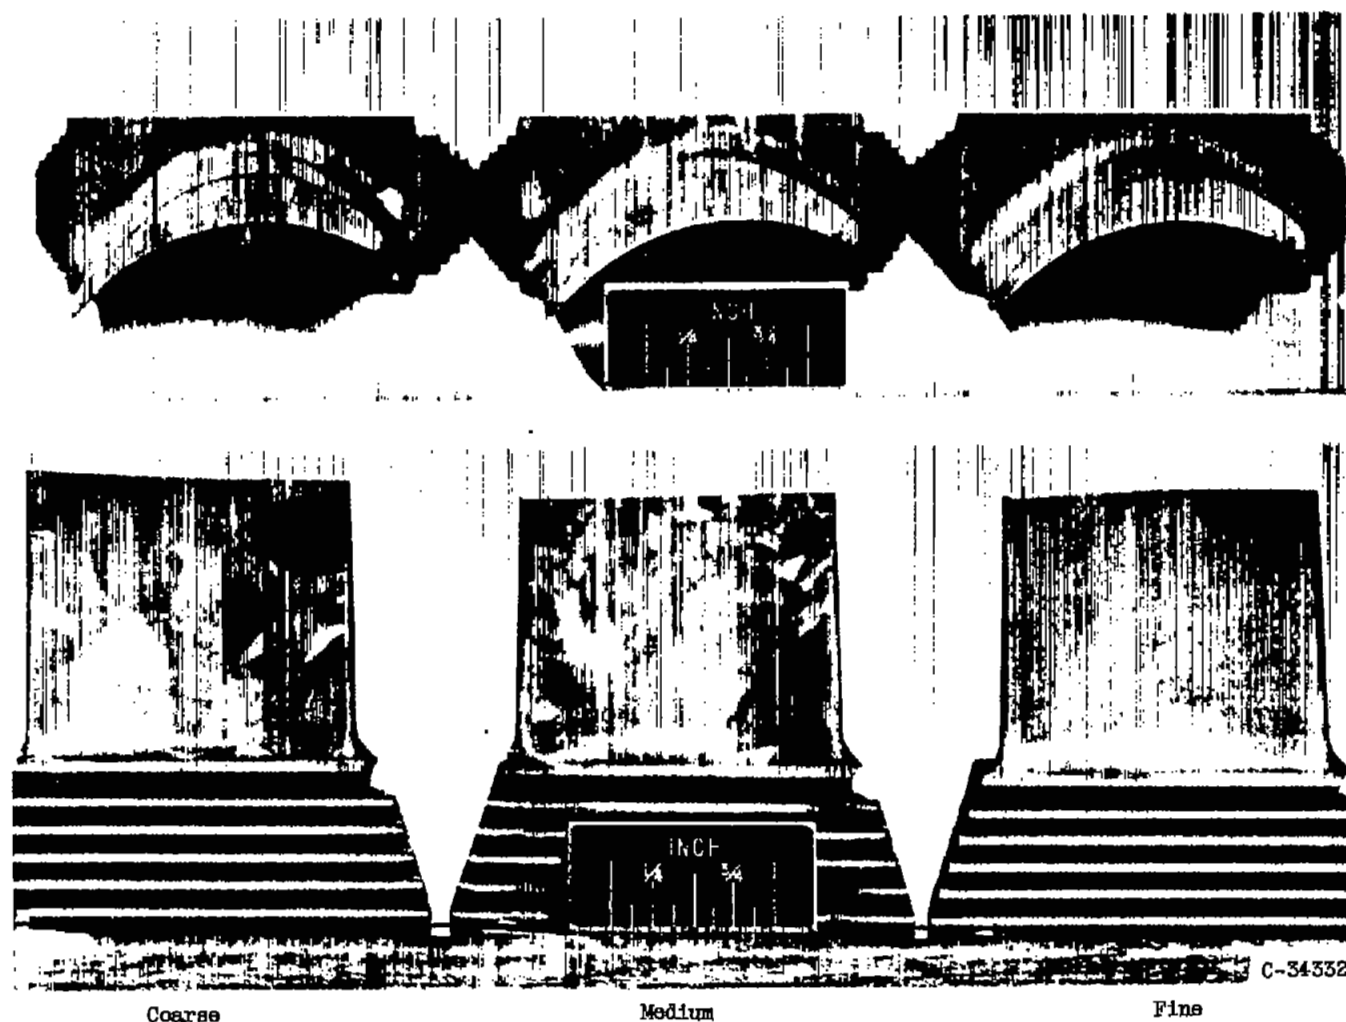
Figure 4. - Typical grain size of 73J blades after engine operation.

Figure 4 shows the grain size of the blades investigated. Macroscopic and microscopic examinations have shown the grain size present in the failure zone to be:

Fine-grained blades - A.S.T.M. 2 to 7 (20,000 to 660,000 grains/sq in.)

Medium-grained blades - 60 to 70 grains per cross-sectional area (270 to 360 grains/sq in.)

Coarse-grained blades - 20 to 30 grains per cross-sectional area (90 to 135 grains/sq in.)

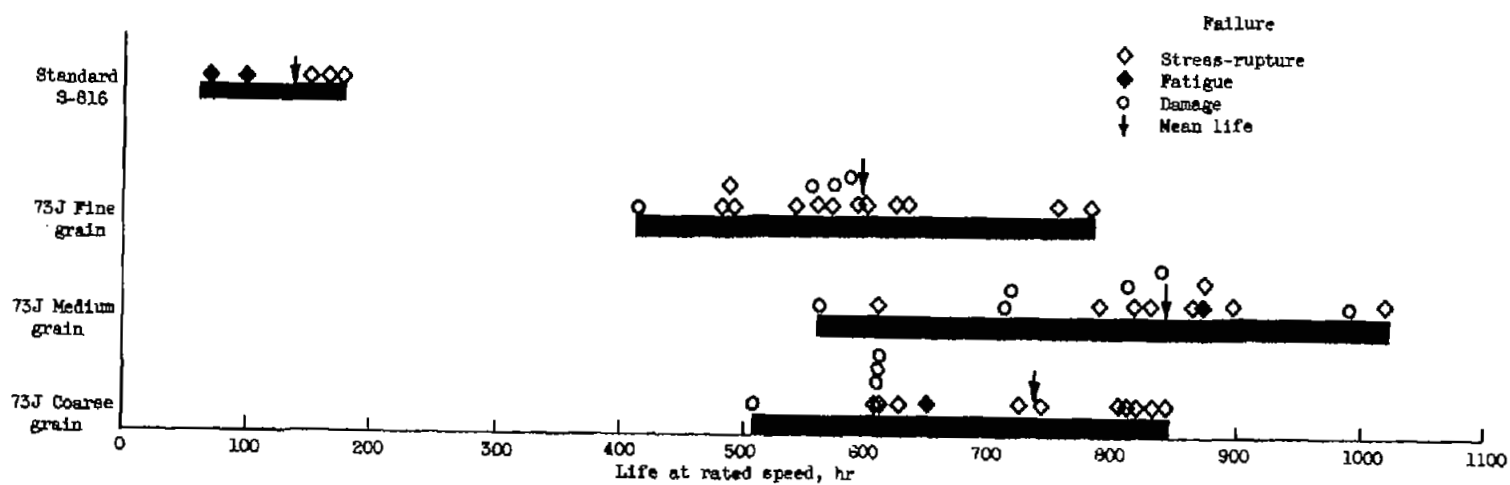
Figure 3. - Blade life of controlled grain-size 73J and S-816 turbine blades.

The engine life of 73J blades of three different grain-size groups and standard S-816 blades is plotted in figure 5. The engine life of all groups of 73J blades was far superior to that of the forged S-816 blades.

From past performance of cast blades, in this type of engine evaluation, it may be generalized that fatigue is the usual mode of failure. In this investigation, the 73J blades failed predominately by stress-rupture. The stress-rupture failures may have been caused by the stiffening of the blades by the increase in cross-sectional area, as previously noted. Damage failures are not considered true failures and will not be discussed. The first failure of the 73J alloy occurred in the fine-grained blades after 484 hours at rated speed. First failures in the coarse- and medium-grained lots occurred after 609 and 612 hours, respectively. The mean life of the fine-grained group of blades was the shortest (594 hr); the coarse-grained blades had an intermediate mean life of 736 hours; and the medium-grained blades had the longest mean life (843 hr). The scatter in blade life present within each grain-size group may be considered low for a cast alloy. Life ranged from 609 to 844 hours for coarse-grained blades, 484 to 785 hours for fine-grained blades, and 612 to 1023 hours for medium-grained blades.

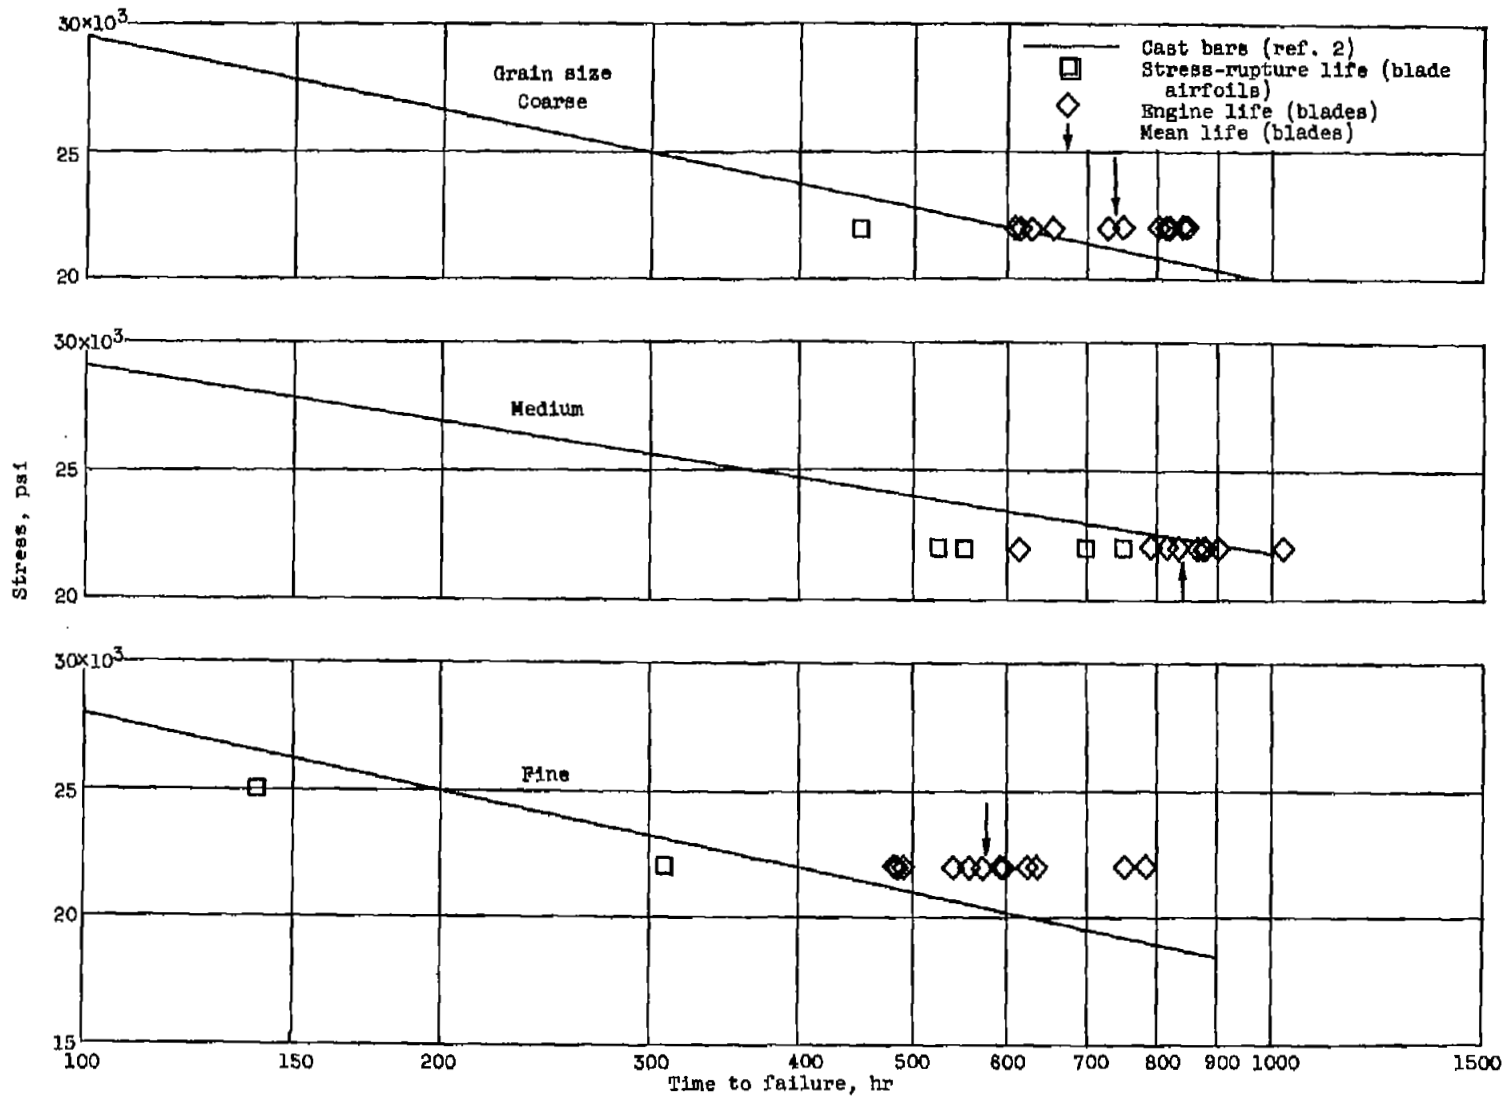
Figure 6. - Comparison of blade life, stress-rupture life of specimens out from blade airfoils, and stress-rupture life of cast bars. Test temperature, 1500° F.

The engine operating data have been plotted in figure 6, along with stress-rupture data obtained from specimens cut from airfoils. For comparative purposes, curves on cast stress-rupture bars presented in reference 2 are also shown. In all cases, the data from blade specimens fell below the values obtained from cast bars. The engine operating life of the blades follow the trend mentioned before, that is, fine-grained blades have shorter life than the coarser-grained blades. The stress-rupture data for both the cast bars and specimens cut from airfoils also follow this trend. Thus it was shown that the blade life, the blade-airfoil stress-rupture life, and the cast-bar-stock stress-rupture life all follow a pattern of increasing life as the grain size changes from fine, to coarse, to medium.

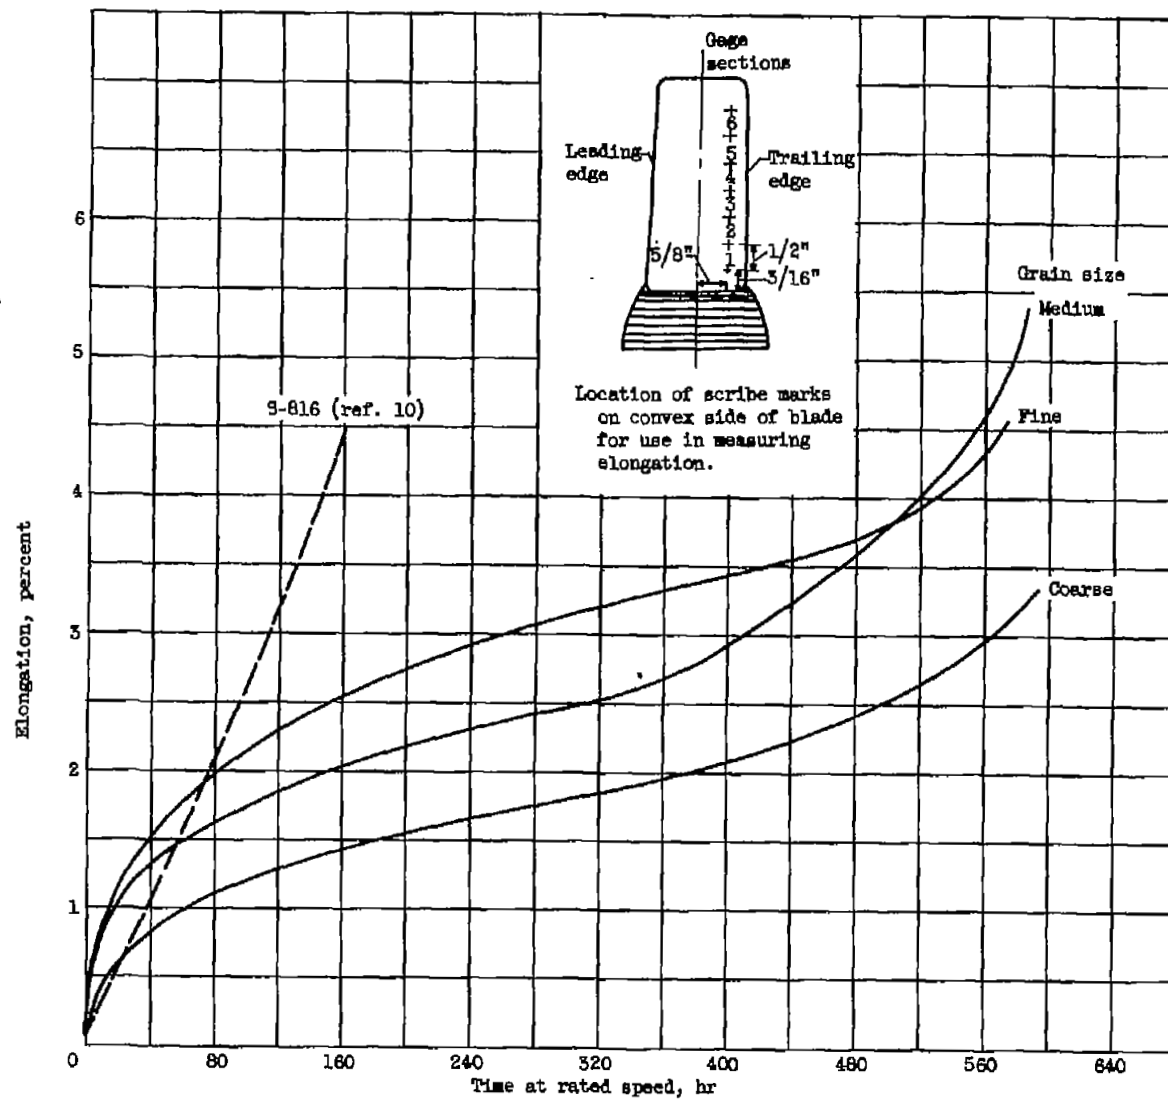
Figure 8. - Elongations of blade airfoils, average of positions 3 and 4.

The elongations occurring in the 1-inch gage length (zones 3 and 4) with the most severe combination of stress and temperature are plotted in figure 8. The total elongations in this zone, where the stress is approximately 21,000 psi at 1500° F, are as follows:

Grain size	Time at rated speed, hr	Elongation, percent
Fine	570	4.5
Medium	588	5.4
Coarse	588	3.3

The slopes of the elongation curves during second-stage creep are essentially the same. Since evidence of third-stage creep appeared in all three grain-size blades before failure, the failures may be considered true stress-rupture failures. Standard S-816 blades operating at the same temperature at a stress of 21,500 psi had an elongation of 4.5 percent in 160 hours (ref. 10). Thus, under similar operating conditions it can be seen that the creep rate of 73J is appreciably less than that of S-816.

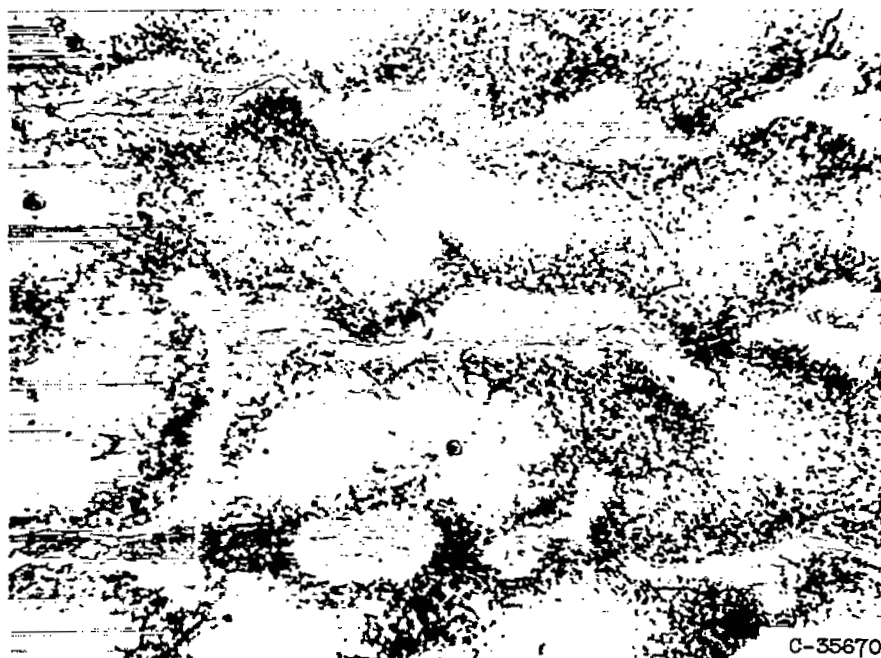
Figure 11. - Coarse-grained 73J alloy operated at rated speed.
Electrolytically etched in 5-percent aqua regia.

Figure 11. - Concluded. Coarse-grained 73J alloy operated at rated speed. Electrolytically etched in 5-percent aqua regia.

Photomicrographs of first and last failures of fine-, medium-, and coarse-grained blades are shown in figures 9 to 11. The grain size of the fine-grained blades was determined by use of the metalloscope because the fineness of the grains permitted a large number to be present in the field of view. However, in the case of both the medium- and coarse-grained blades, the interdendritic networks and precipitates made it difficult to detect the true grain boundaries. The only way grains could be separated from each other in many areas was by the change in orientation of the interdendritic carbide networks from grain to grain. It was difficult to observe significant microstructural differences between first and last blade failures since greater differences frequently were found within a given blade. Coring of the cast structure and an anisotropic resistance to etching solutions probably obscured any differences in precipitation with time at temperature.

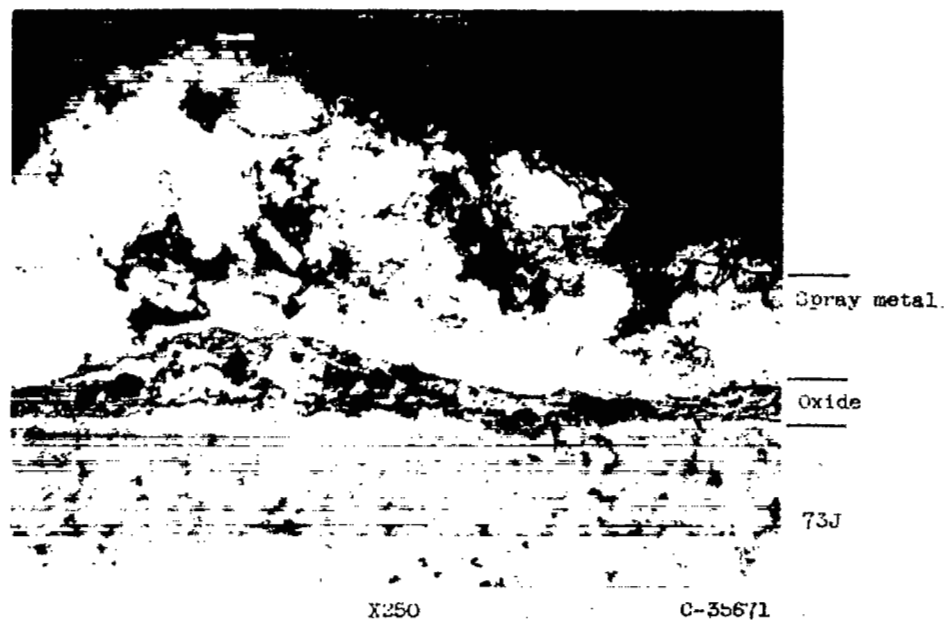
Figure 12. - Aluminum deposited on convex edge of blade as result of engine fire. Electrolytically etched in 5-percent aqua regia.

After 534 hours of rated speed operation the engine caught fire. An aluminum casting was melted, and the leading edges of the blades were sprayed. A typical sprayed area is shown in figure 12. It may be observed that the sprayed alloy adhered to the oxide coating on the blade surface and no alloying or metal-to-metal contact of the aluminum to the 73J was detected. Therefore, it was concluded that the presence of the sprayed metal on the blades did not affect the operating life of the 73J alloy.
